Effect of Hydration in Magnesia Based Refractories for Lime Kiln Industry

Debarati Nandy*, Soumen Banerjee**, S.K. Bhattacharjee***

* Sr. Design Engineer (Refractories), MECON Limited, Ranchi

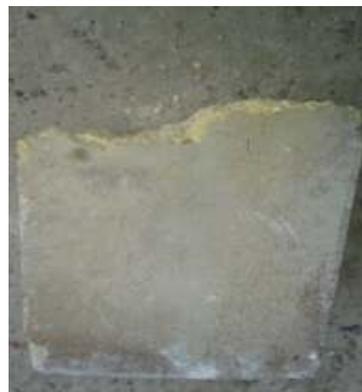
Fig-1: Hydrated brick

The hydration of magnesia containing bricks shows an external white coating with brittleness, loose structure and cracking. Only outside whitish coating in bricks cannot be considered as hydrated bricks. If the white magnesium hydroxide continues to the inside of the brick which can be checked

by breaking it through, the degree of hydration may be considered in advanced-stage.

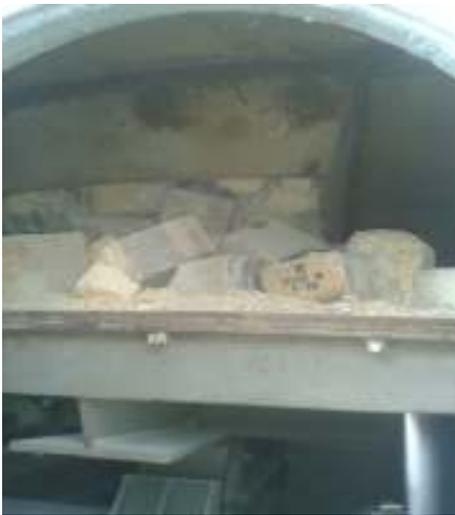
Fig-2: Brick collapsed from kiln

The combustion zone of lime kiln is lined with basic bricks which are prone to hydration. Once installed and if the kilns are not commissioned early, the bricks get exposed to the humidity and the resultant hydration not only causes expansion of bricks but also reduces its inherent strength. The loss of strength is irreversible. Collapse of refractory lining was reported from several lime kiln projects in recent years.

Sl. No	Plant	Erection of Refractories done at site	Refractories found hydrated/ collapsed
1.	IISCO Steel Plant	Supplied: Nov, 12 Erected: April, 13	Collapsed: June, 14 (Before heating up)
2.	Neelachal Ispat Nigam Limited (NINL)	Supplied: Feb., 12	Hydrated: July, 13 (At site)
3.	Rourkela Steel Plant	Supplied: Jan, 13 Erected: April, 13	Collapsed: Oct., 2014 (During heating up)

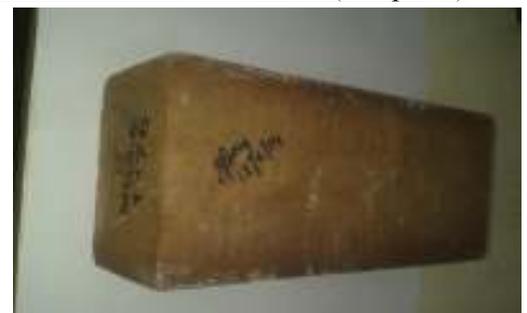
Fig. 3

• **Appearance of Un-used brick (sample-3)**

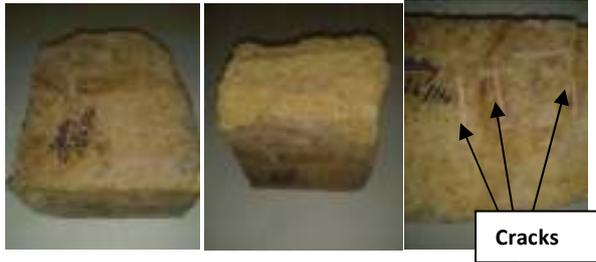
Fig. 4

In one reference project, the lime kiln was kept idle without taking precautions for more than a year. Subsequently the bricks were got hydrated and collapsed. The debris collected at the bottom of the kiln which indicated that most of the collapsed bricks were the basic bricks. Two brick samples were collected from the affected area of lime kiln. One unused brick was also collected from the store for comparative study.

- Appearance of used brick (sample-1)

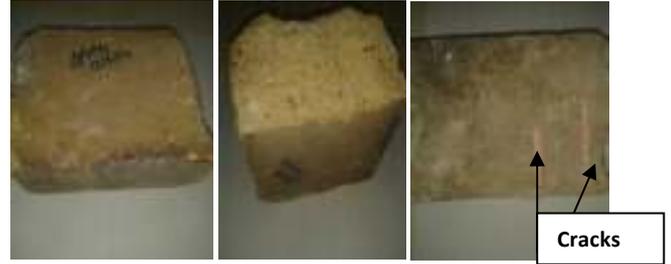
Fig. 7

- Appearance of used brick (sample-2)
